NASA CR-72855
R-8406

PROTECTIVE COATING SYSTEM FOR A REGENERATIVELY
COOLED THRUST CHAMBER

FINAL REPORT

Contract NAS3-11187

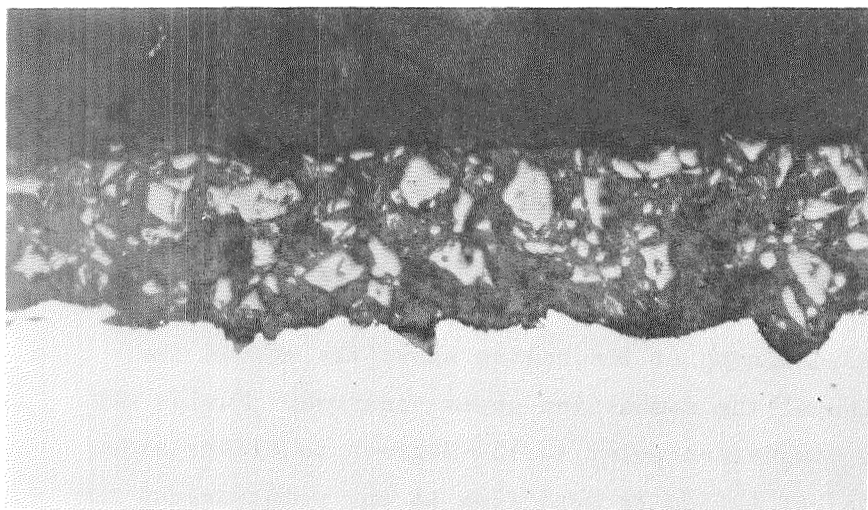
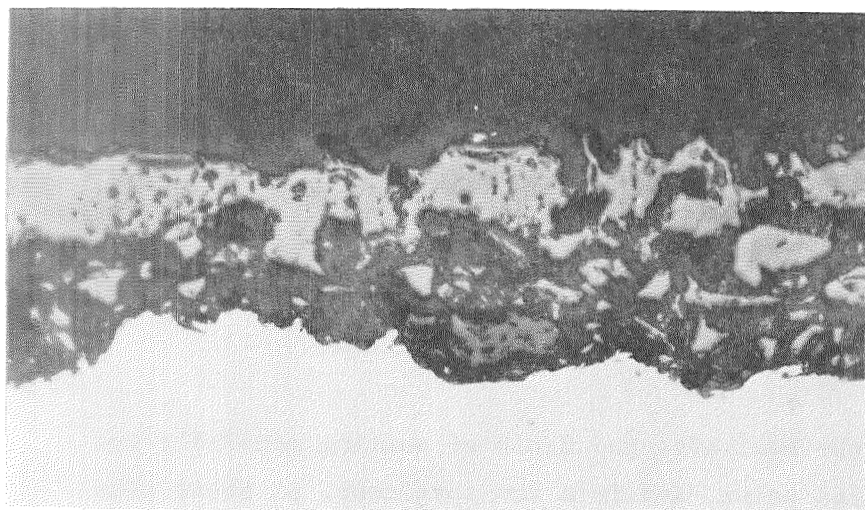
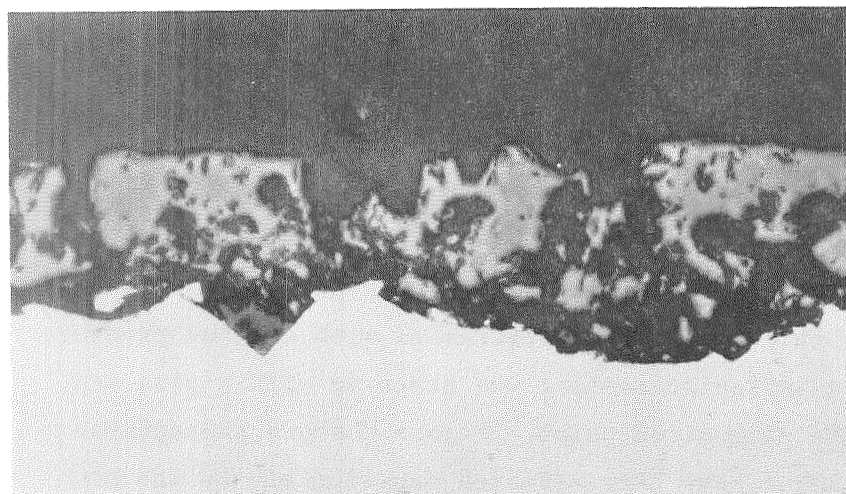
Figure 17. Microstructure of Coated Specimens Tested in the Rocket Engine Comparing Effects of Temperature. Magnification X400.

Typical microstructure
in a low heat flux
location

Specimen 34
Test Zone;
0° from stagnation
point

Maximum depth to which the effects of heat were observed varied from 30 to 100 percent of total thickness, and it increased with chamber pressure. The largest depth of heat-affected coating was observed within plus and minus 45 degrees from the stagnation point. Figure 17 shows photomicrographs of two specimens that have been affected considerably by the high temperature.

Comparable microstructures are found in Reference 1, pp. 81 and 82, wherein the coated specimens attained an optical pyrometer temperature of more than 4400 F in arc-plasma jet tests. Based on comparable tests in the arc-plasma jet, then, the evidence is that surface temperatures of the coated specimens tested in the rocket engine reached 4400 F.

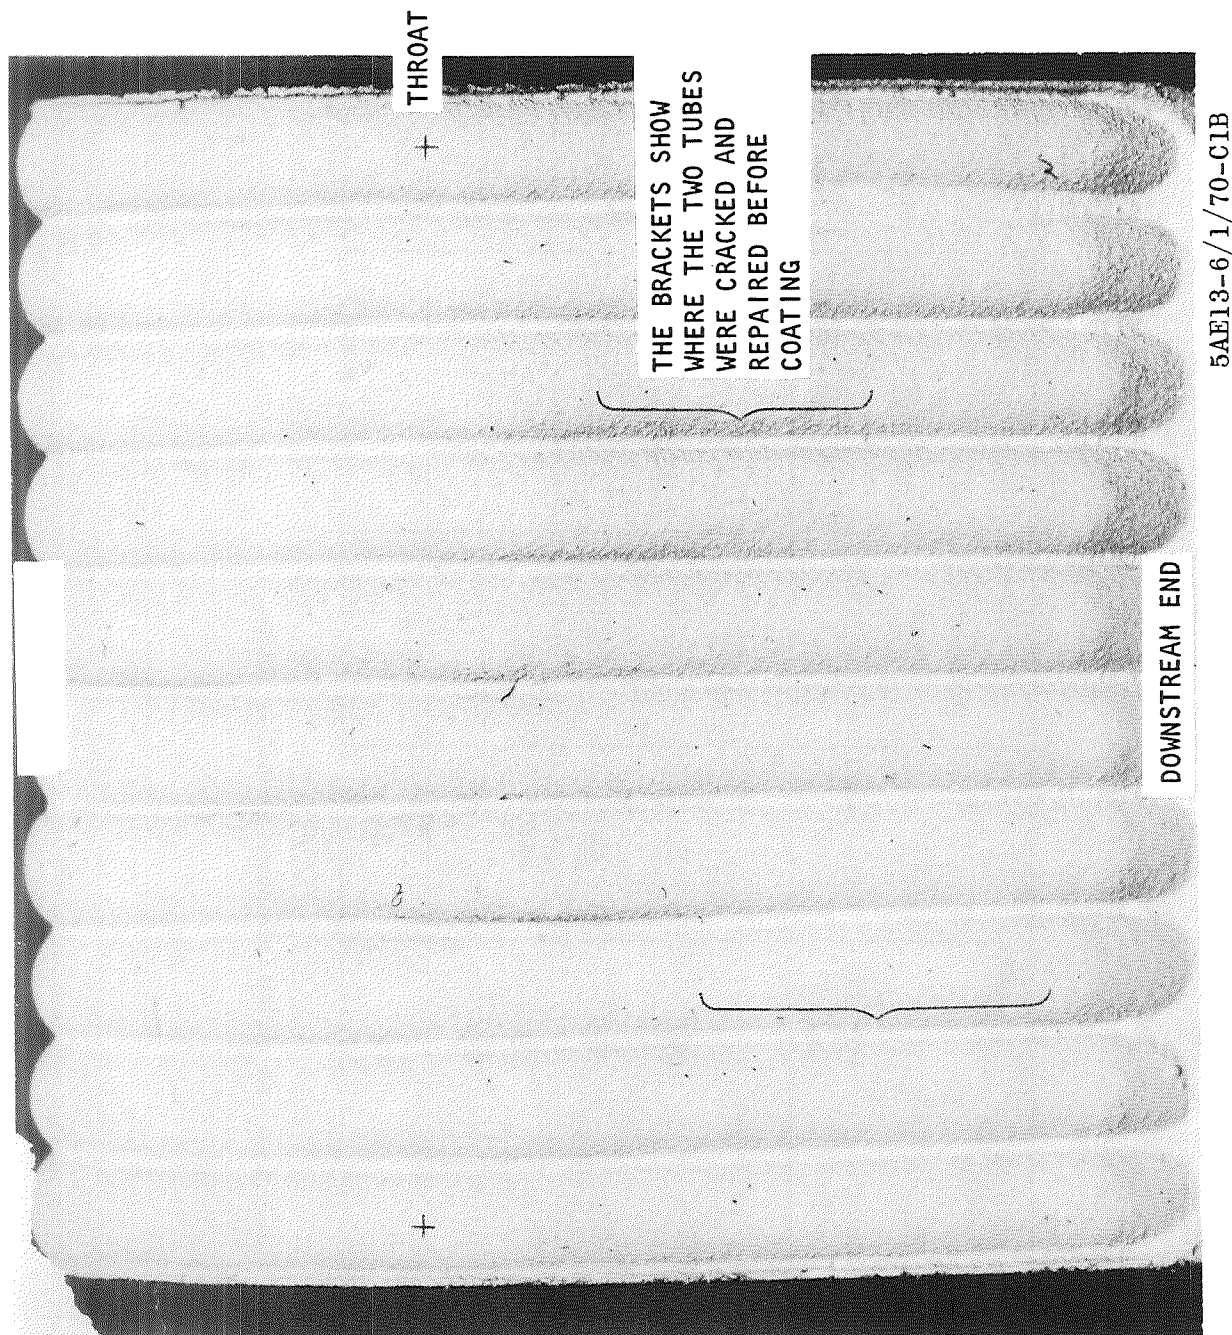
Figure 18. Top View of Tube Wall in the Coated Condition (Mag X3.3).

tion of the two repaired areas, indicated in Fig. 18, were not apparent after the coating was applied, nor for that matter, after the bare tube was grit-blasted.

recoated in the same way as before. Thus, the coating was tested on a repaired tube substrate in two locations (Refer to Figure).

Repaired Tubes. The coating was unaffected by the series of three tests where it was applied over the braze-repaired tubes (see Figs. 18 and 20). This demonstrated the possibility of extending the life of the thrust chambers by repairing and recoating certain areas, even after some tubes have failed.

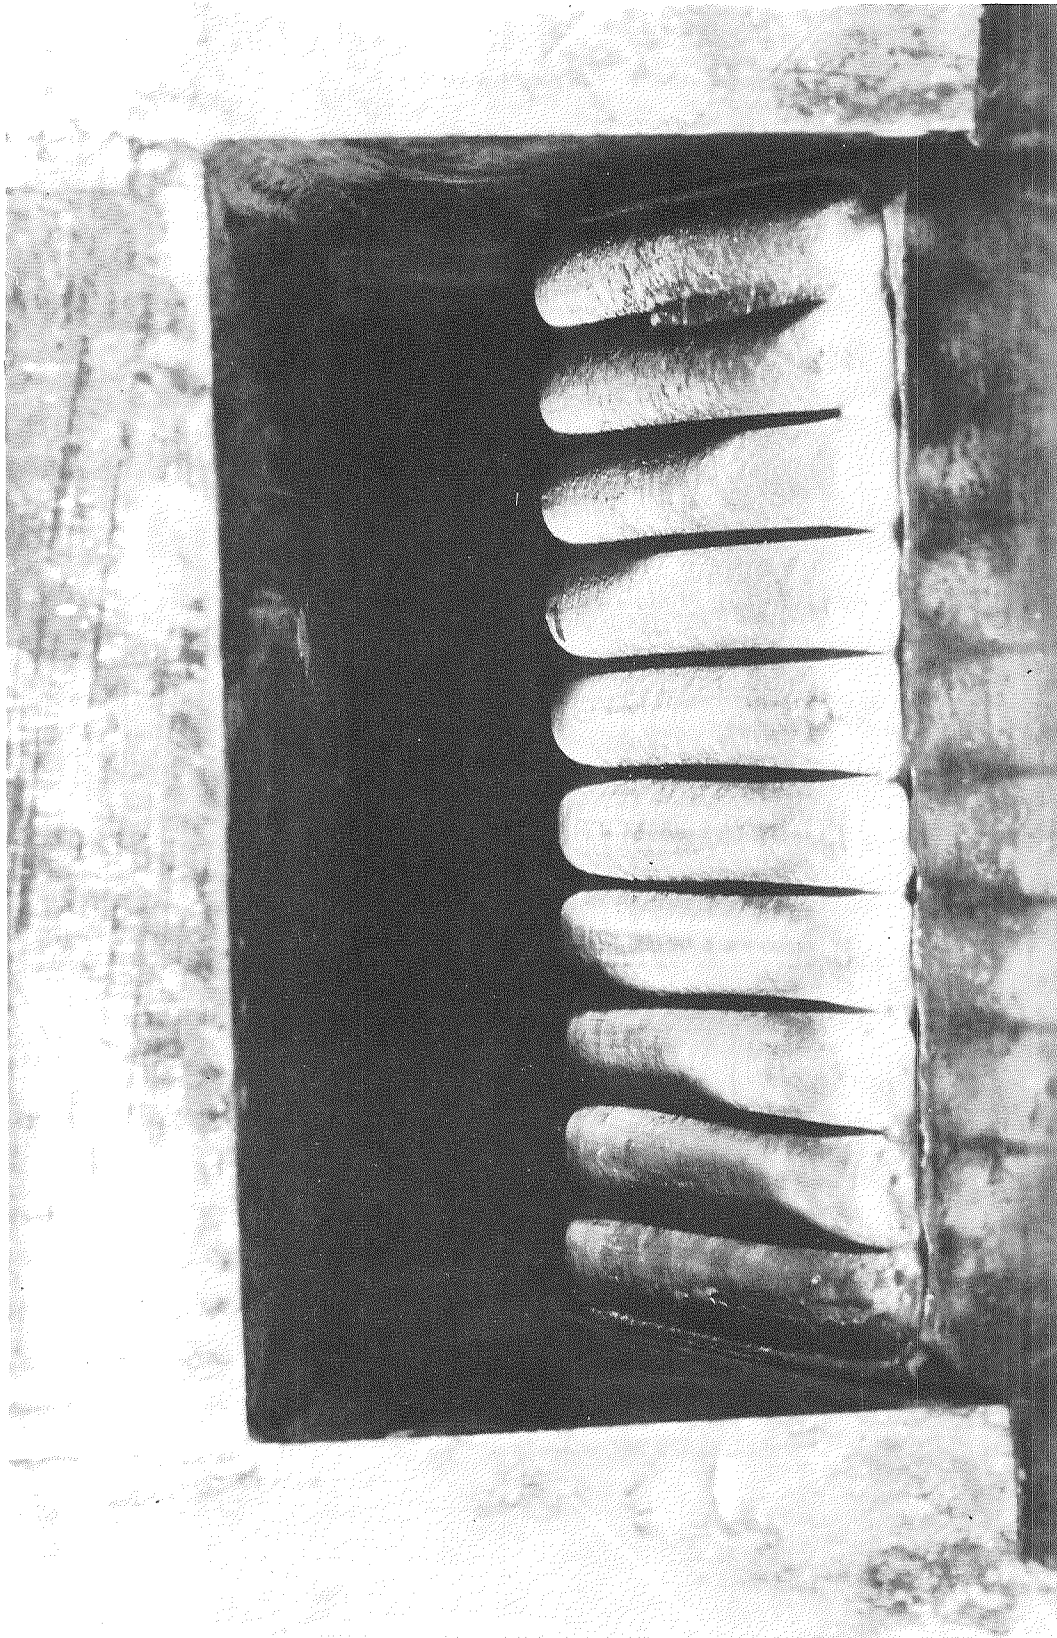
Figure 19c. Condition of the Coating After Firing for an Additional
20 Seconds at 366 psia Chamber Pressure

After the Second Firing. Integrity of the coating, in general, remained very good after the second firing (Fig. 19c), this time at a chamber pressure of 366 psia for 20 seconds. No cracks were observed and the coating was still hard.

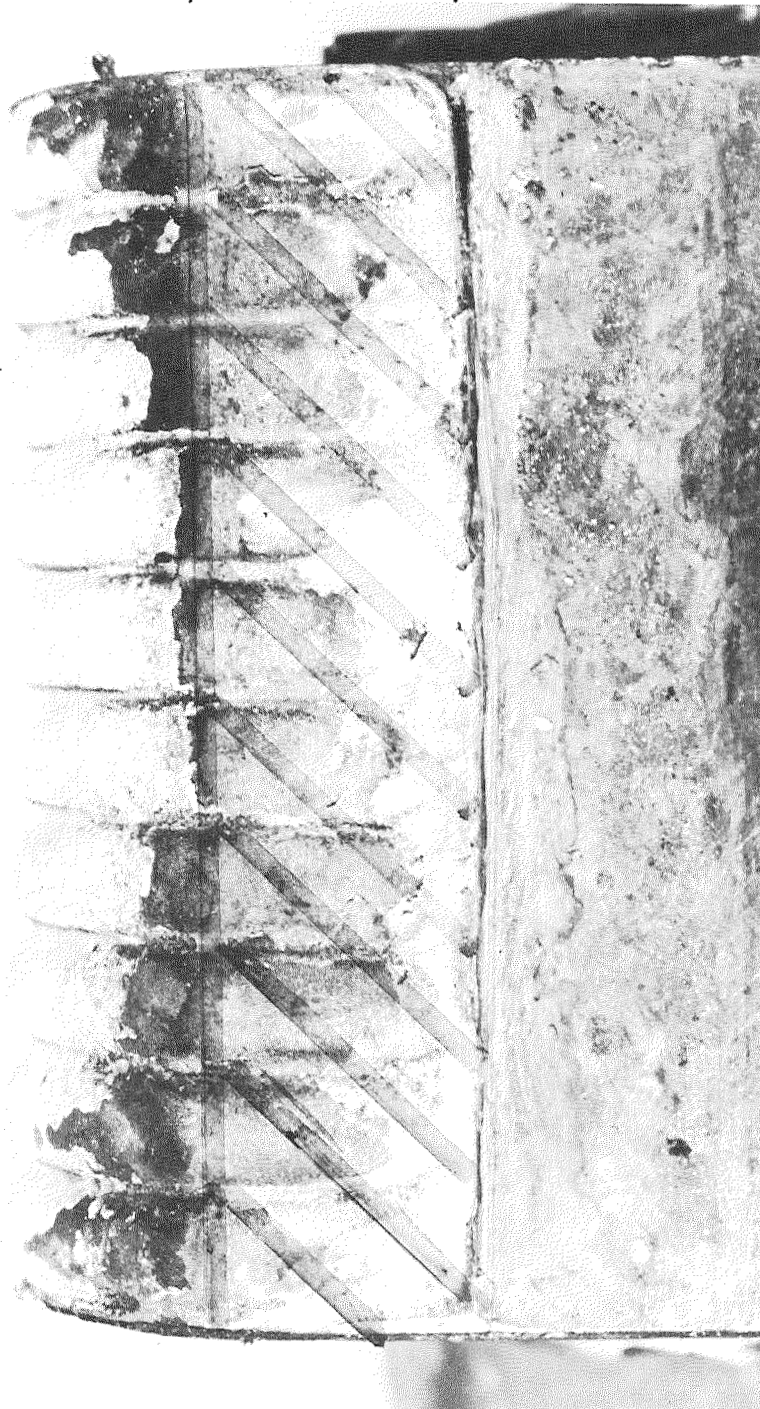
THIS AREA MATED
INTO A SLOT MACHINED
IN THE FACE OF THE
COMBUSTOR

the face of the combustor. A recessed area had been milled in this face so that the protruding coated tubes would not be smashed when the throat insert was bolted to the combustor (refer to Fig. 8). Thus, there was an opening of unknown dimensions between the combustor face and the tubular wall. Hot combustion gases flowed into this open slot, but since the environmental conditions are unknown, the heat transfer conditions cannot be evaluated. Damage to the coating in this zone could have resulted from the milled slot being too small such that when the tube crowns expanded due to heating from the combustion gases, they pushed into the face of the combustor, crushing the coating.

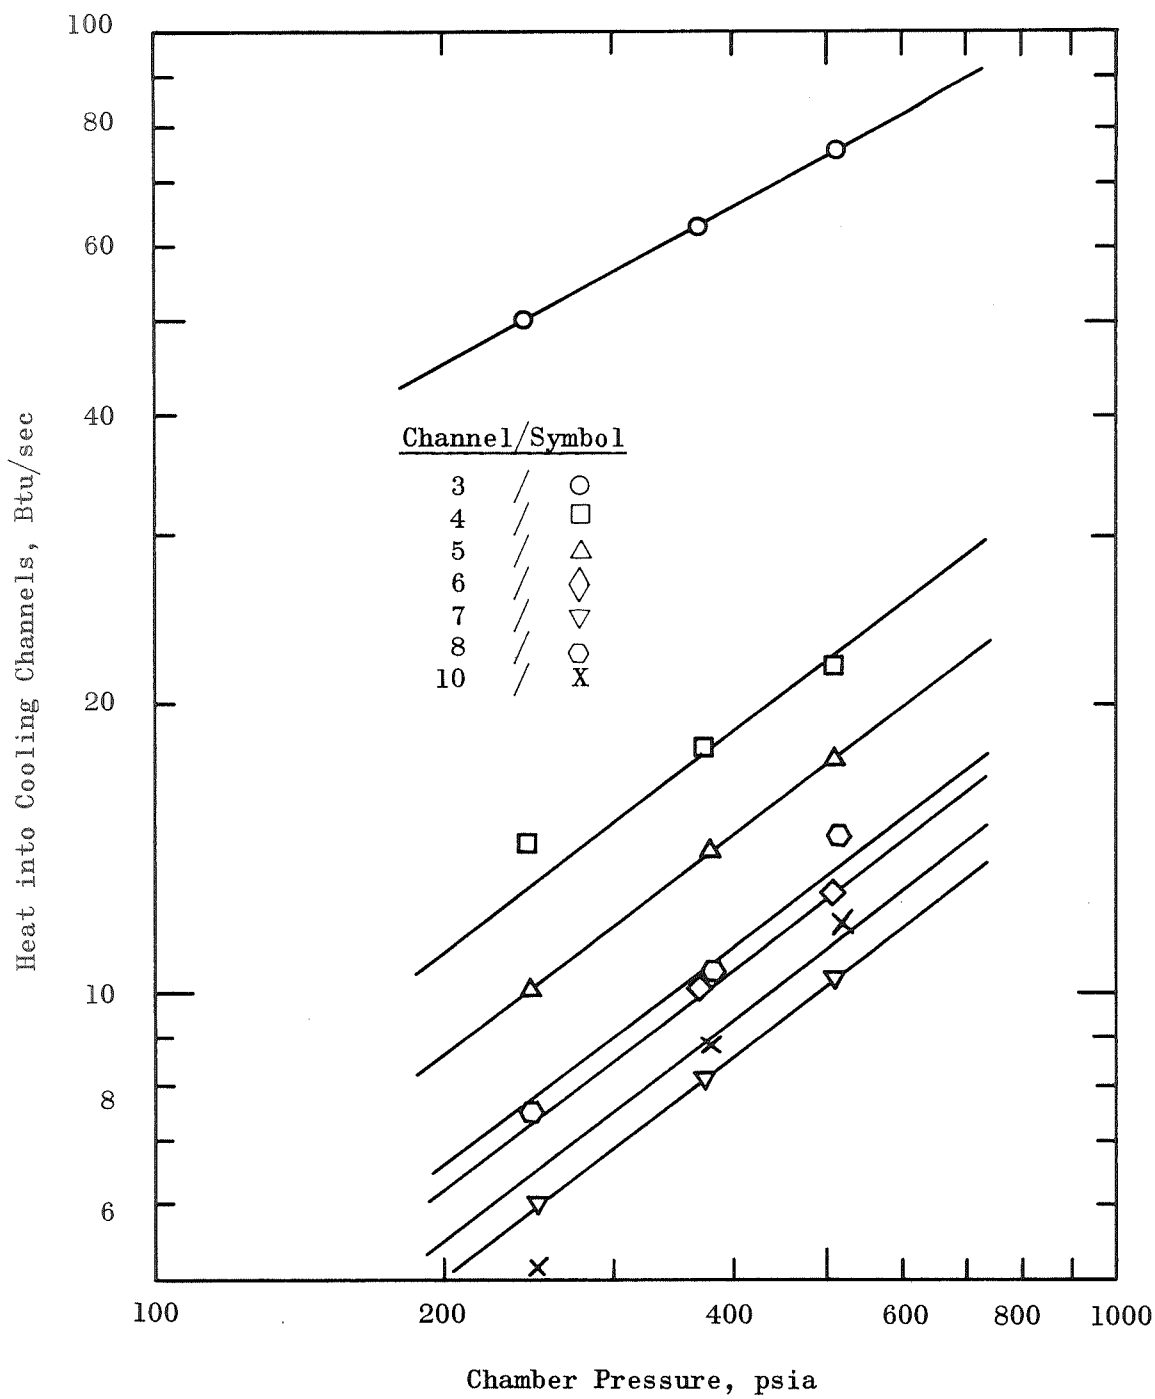
Figure A-7. Measured Heat into Coolant Channels

test #90. They were subsequently replaced. The data from channels 4 through 10 were found to lie close to straight lines with a slope of 0.8 which corresponds to the theory of turbulent boundary layer heat transfer. Utilizing this slope, all of the heat transfer data from these channels were smoothed to fit this correlation. This data smoothing process made only trivial changes in heat fluxes in test #91 and #92, but moderate increases were made in test #90 in channels 5, 7, and 10. These effects are shown in Fig. A-7. Actual data points are indicated by numbers corresponding to the channel number. Channel 9 is not shown since it is nearly co incident with number 8.

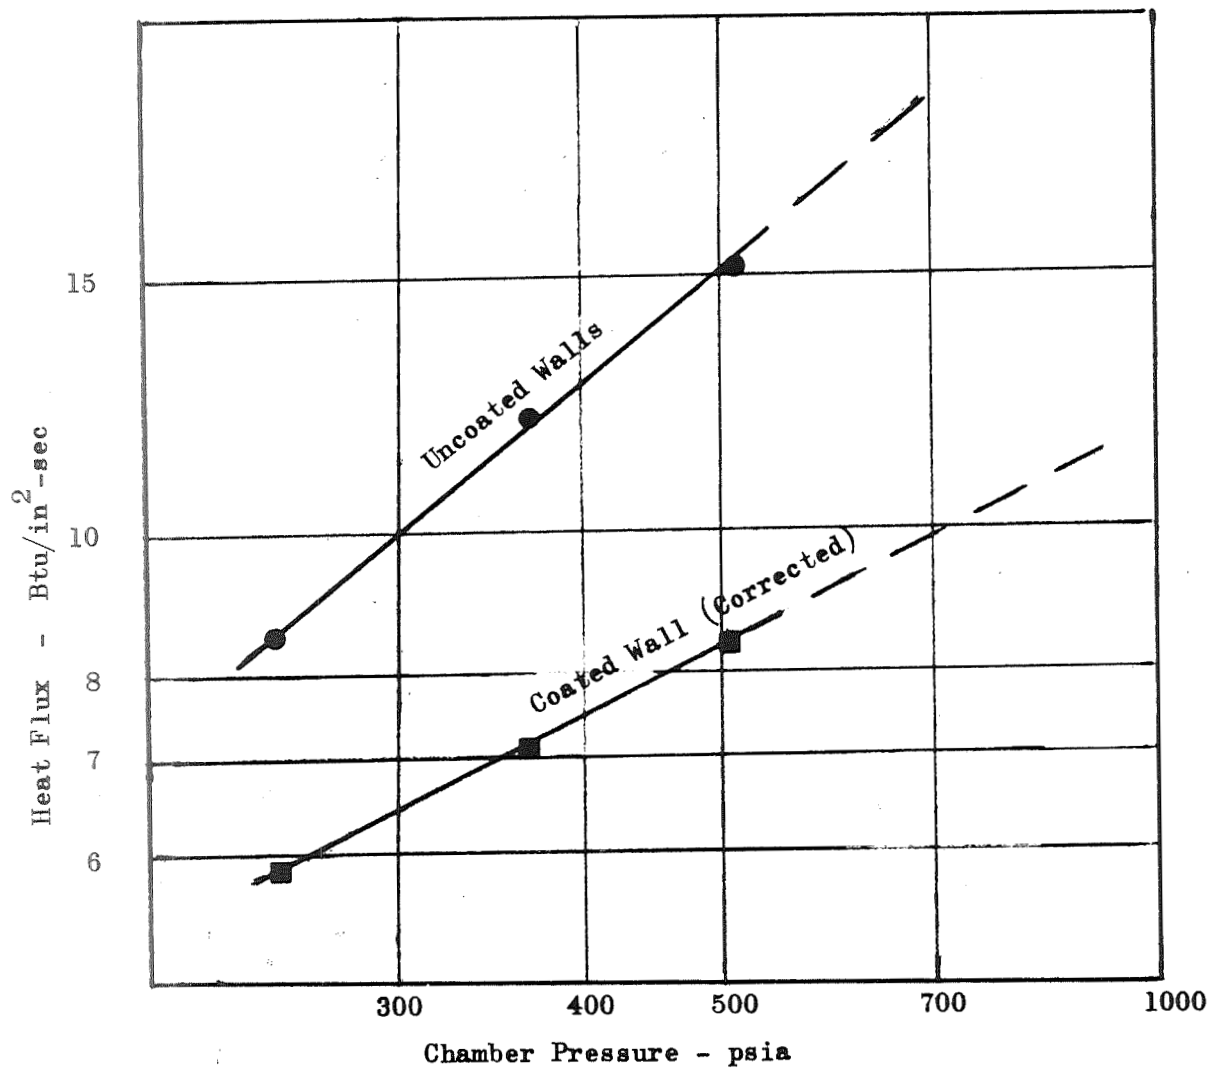
Figure A-8. Heat Flux Reduction Due to Coating

The exact amount of heat flux reduction for a particular thickness under a particular application environment may be somewhat indefinite, but for all but the most minimal of heat fluxes, even a small reduction in heat flux results in significant decreases in wall temperature, and, in turn, reductions in wall temperature result in lower applied stresses, higher strength, and greatly increased fatigue or creep life of the metal component.
